Hydraulic Lime Mortar in Sweden with examples of natural and early Portland cement

Sölve Johansson

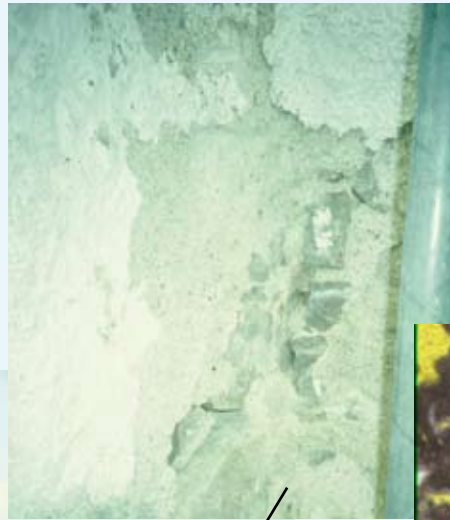
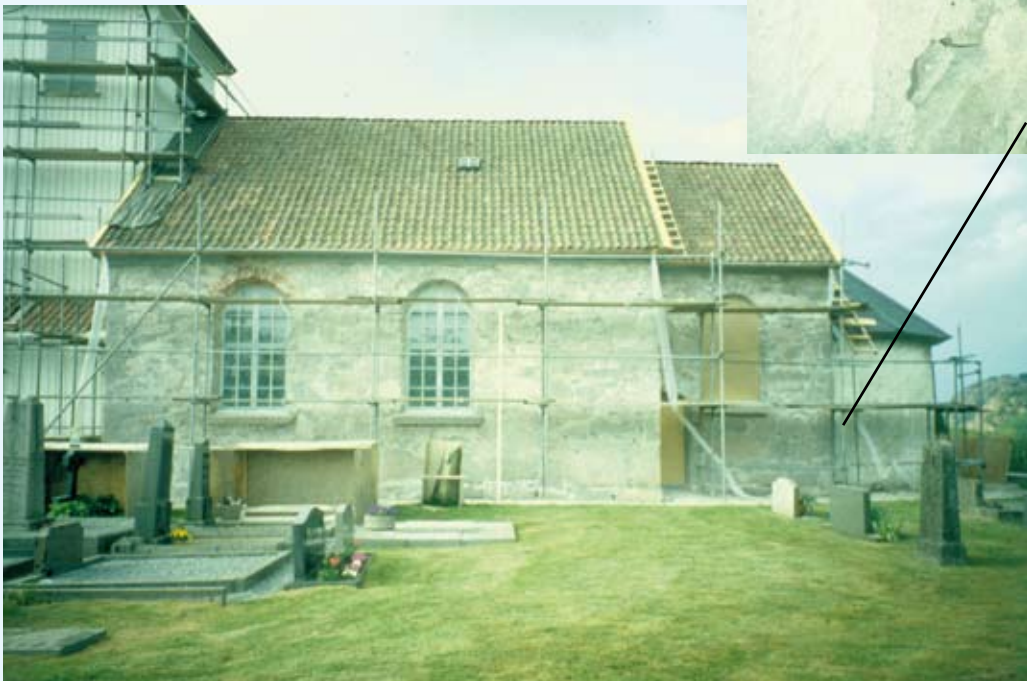
Pure lime mortar - Norwegian lime

Bärfendal Church Bohuslän (1200).

Masonry mortar. Brown-grey. Lime from the Oslo region? CI = 0,09.

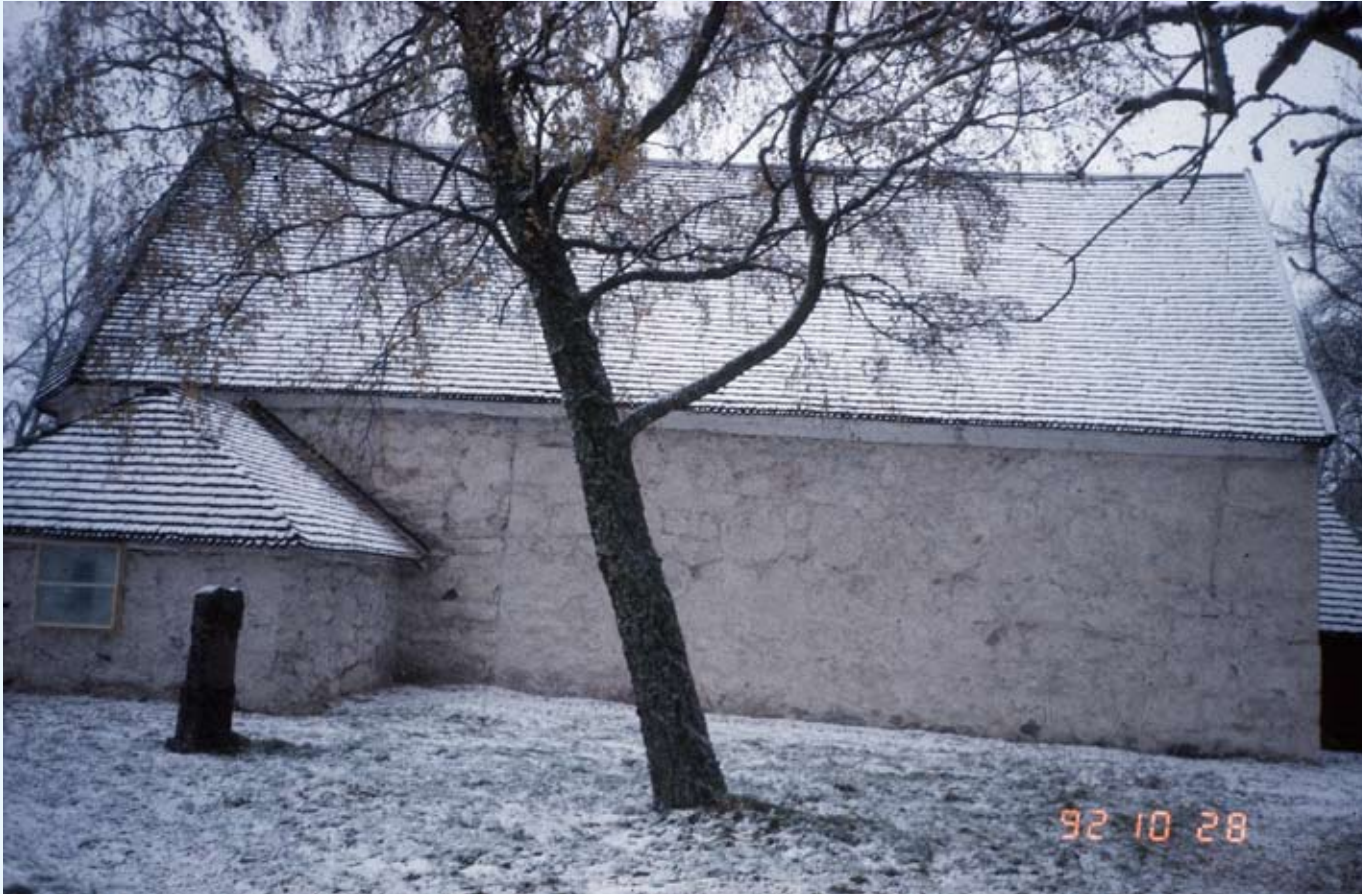
Natural sub-hydraulic lime mortar - Kinnekulle lime

Old Ornunga Church Västergötland (1200). Masonry mortar and smoothed joints. Brown-grey. Lime from ortoceratite limestone Kinnekulle. $CI = 0,23$. There is even Kinnekulle lime based on stinkstone.

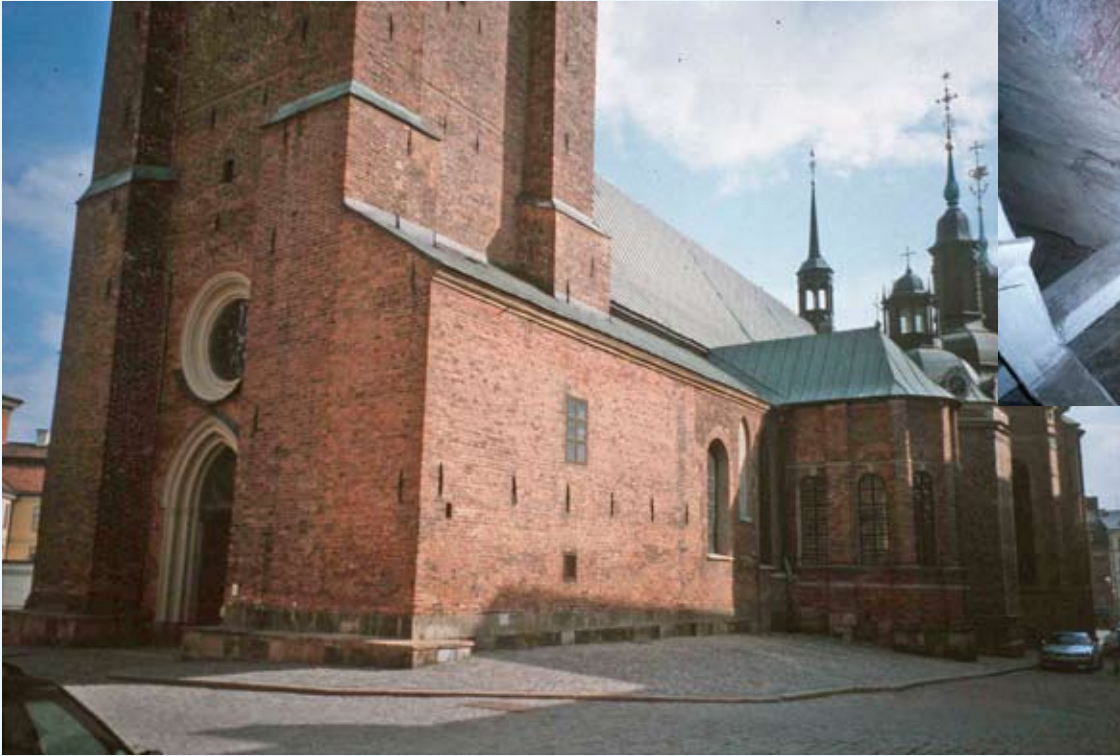
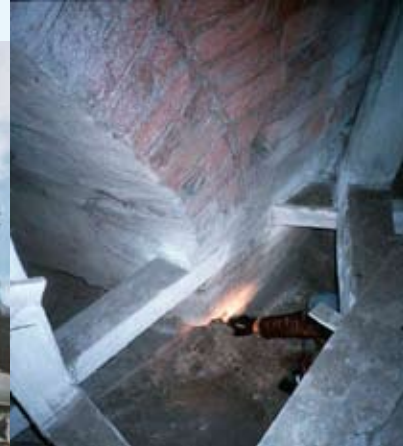
Natural sub-hydraulic lime mortar - Runmarö lime

Franciscan Abbey Stockholm (now Riddarholm Church) (1270-92). Masonry mortar. Yellowish. Lime from Runmarö at the Stockholm Archipelago. $CI = 0,17$.

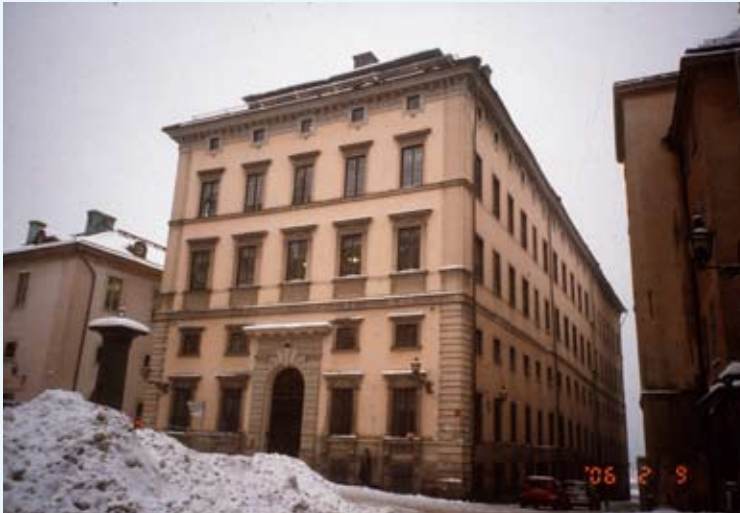
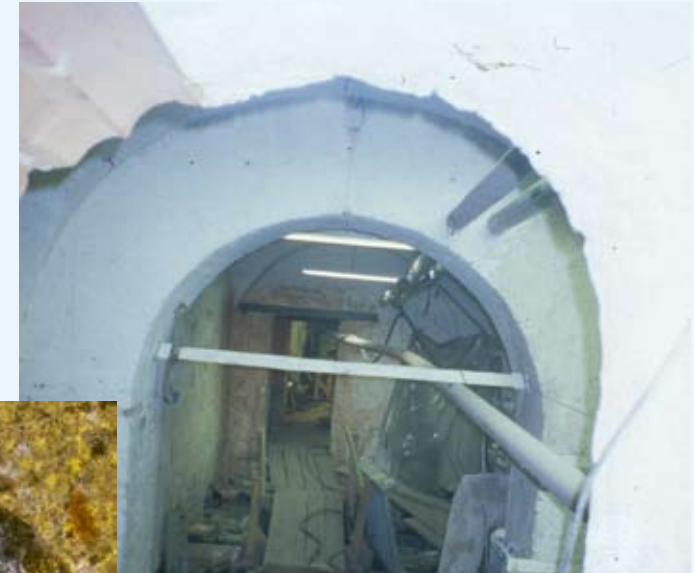
Natural hydraulic lime mortar - An early example

Weighing House Stockholm (1595-1603). Masonry mortar. White. Runmarö lime, lime from ordovician Åland lime stone or lime from Dagö in Estonia. $CI = 0,37$ (feebly hydraulic lime).

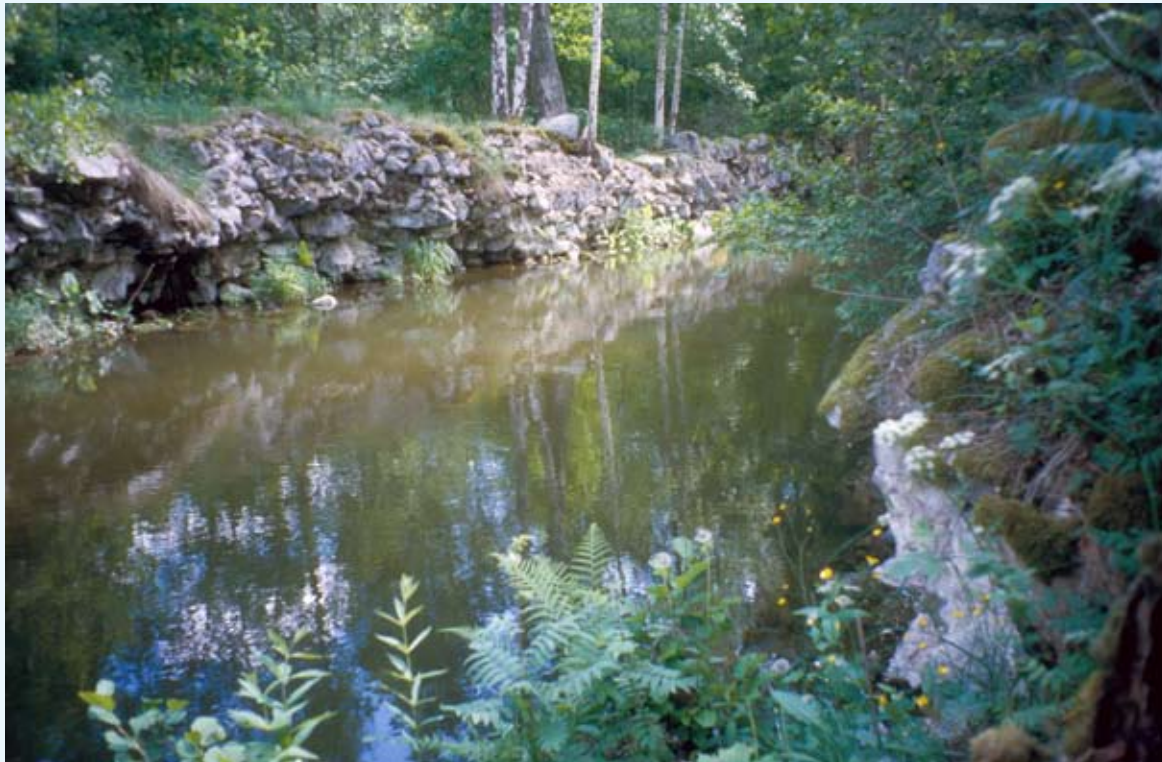
Natural hydraulic lime mortar - An infrastructure example

Lock Old Hjälmare Canal Västmanland (1770-76). Masonry mortar.
White/grey-white. Lime from dolomitic limestone from Lena Uppland.
CI = 0,51 (moderately hydraulic lime).

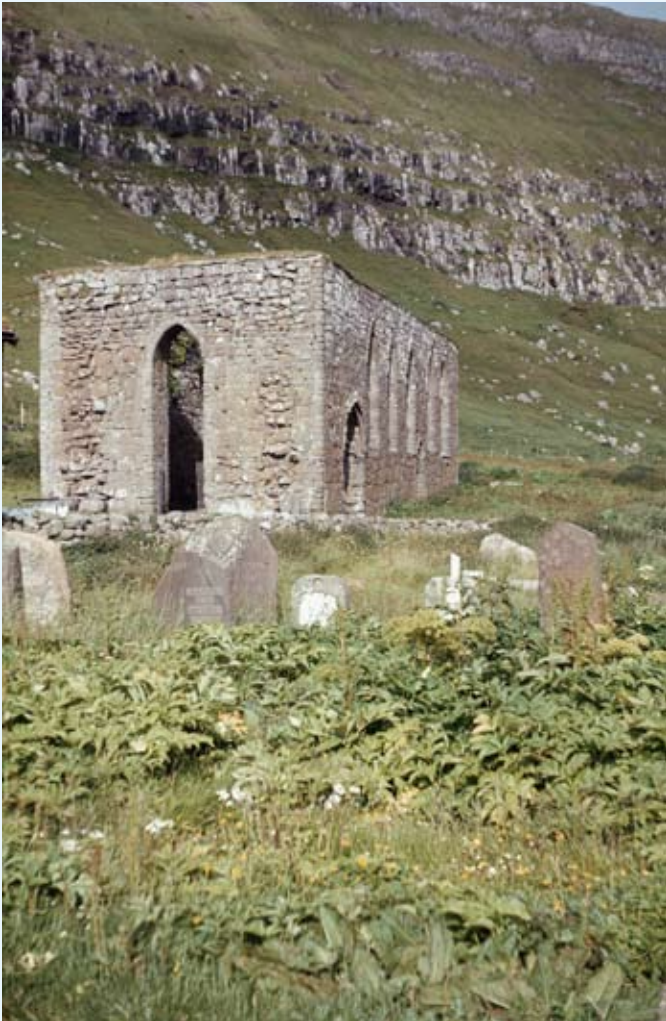
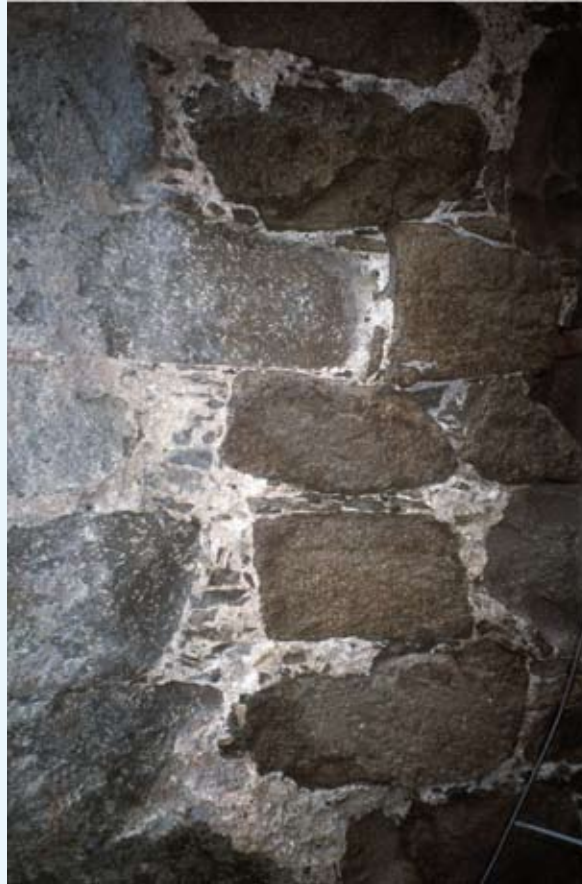
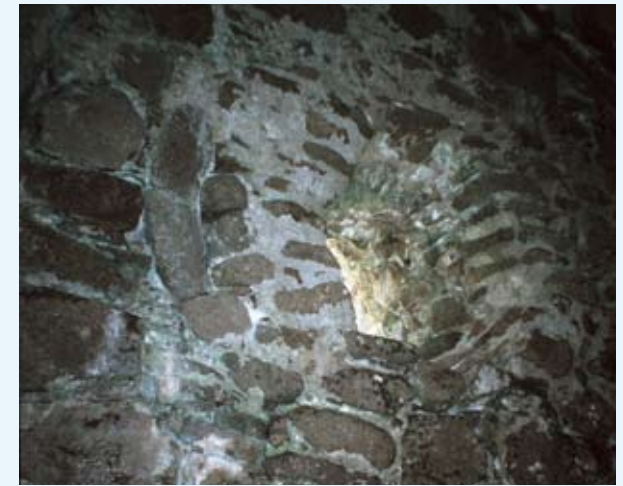
Natural pozzolan lime mortar -

Cathedral of Kirkjubøur Faroe Island (1300). Render/jointing, masonry mortar and inner wall mortar. Light. Lime from shells (pure lime) together with pozzolana from volcanic ash or tuff. $Cl = 0,1-0,63$ (pure lime - moderately hydraulic lime).

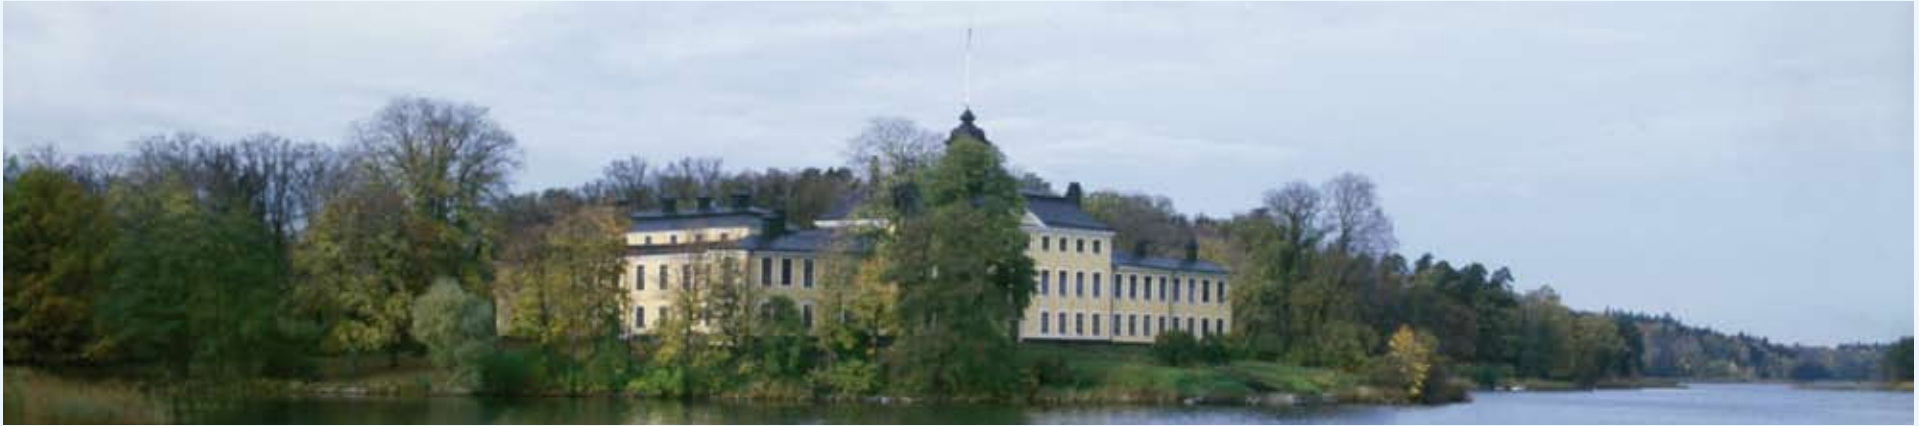
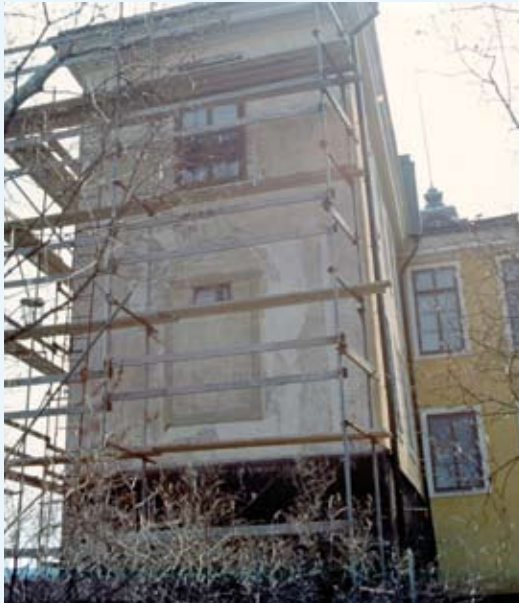
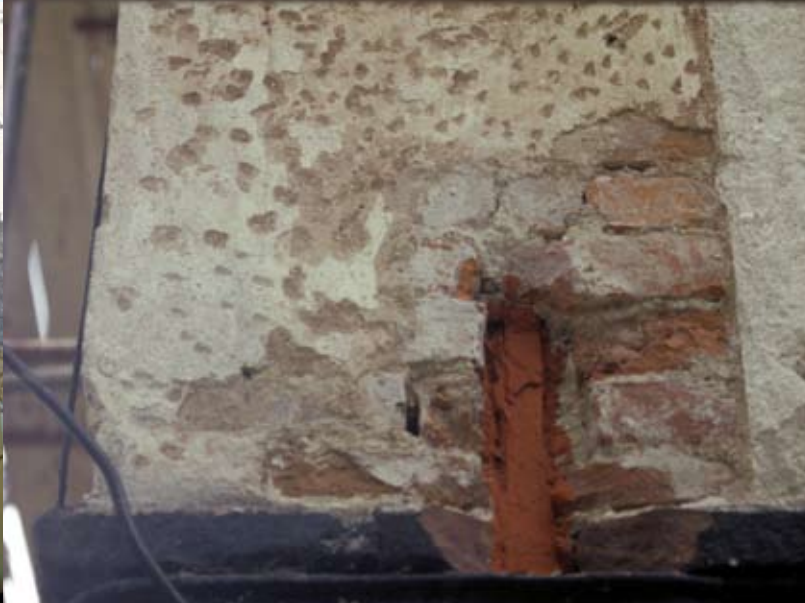
Brick dust lime mortar - “Tessinrender”

Ulriksdal Palace Stockholm (1671-1715). Arkitekt Nicodemus Tessin the elder. Render. Brown-red. Unknown lime together with an artificial pozzolan very fine brick dust.

CI = 0,22 (sub-hydraulic lime).

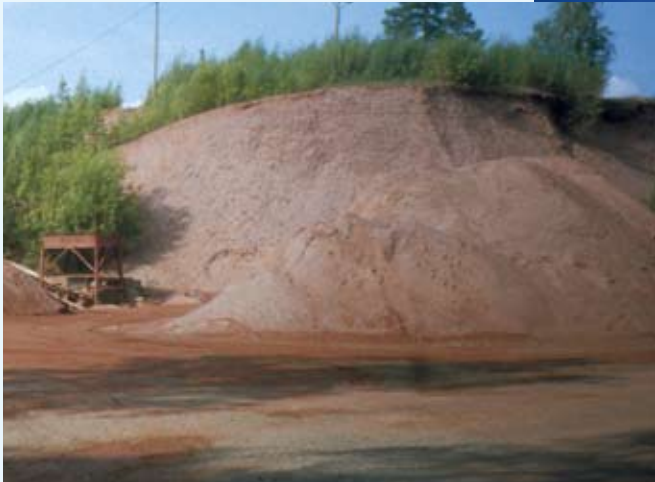
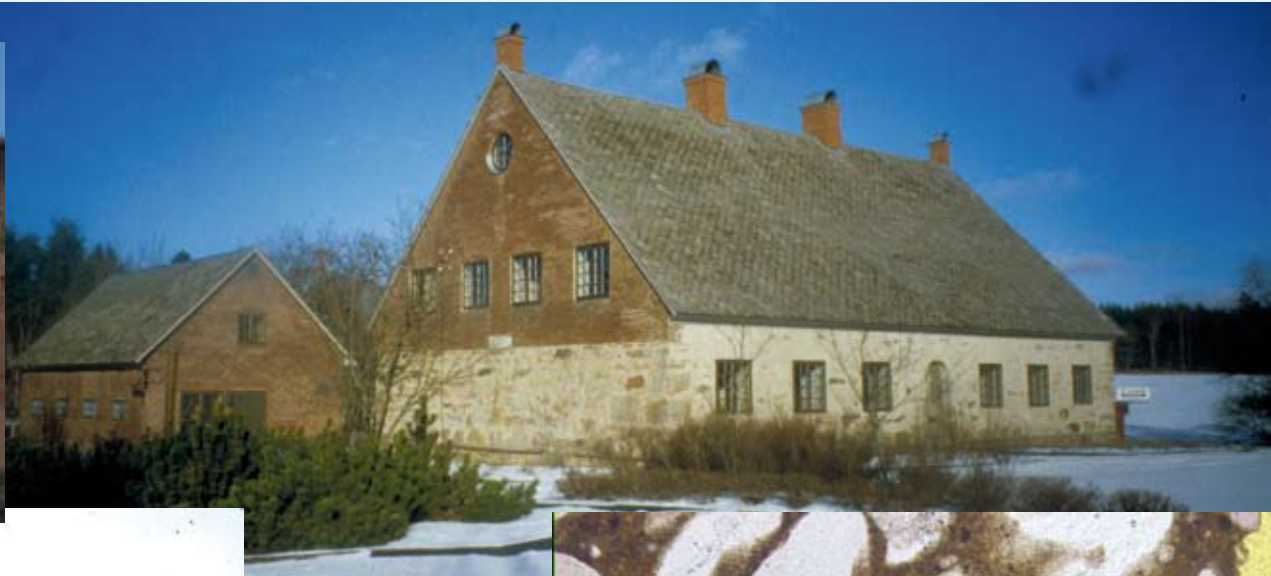
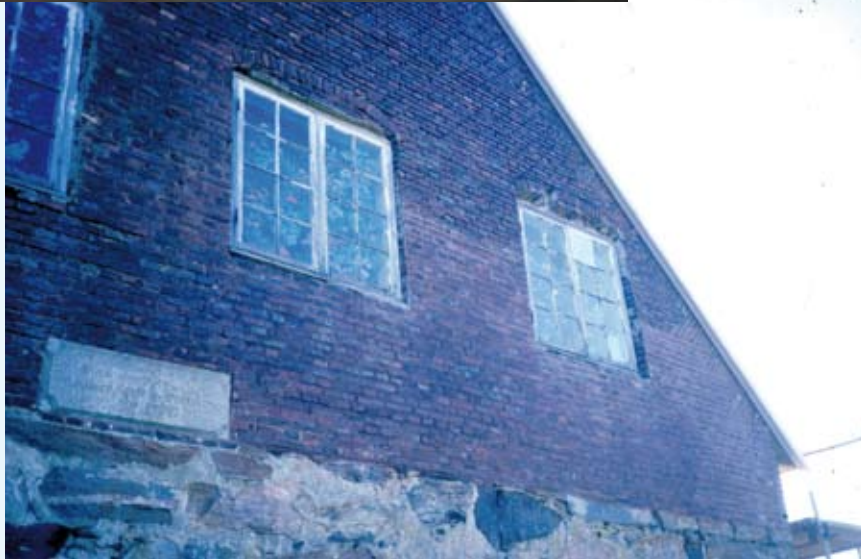
Burnt alum shale lime mortar - The Swedish cement

Onsjo manor Västergötland (1788).

Jointing. Red-brown. Lime from stinkstone (pure lime) together with an artificial pozzolan burnt alum shale from Hunneberg nearby. CI= 0,52 (moderately hydraulic lime.)

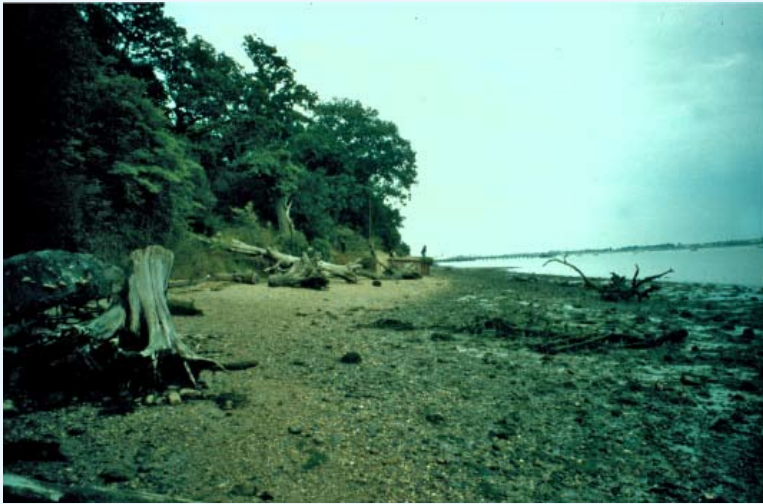
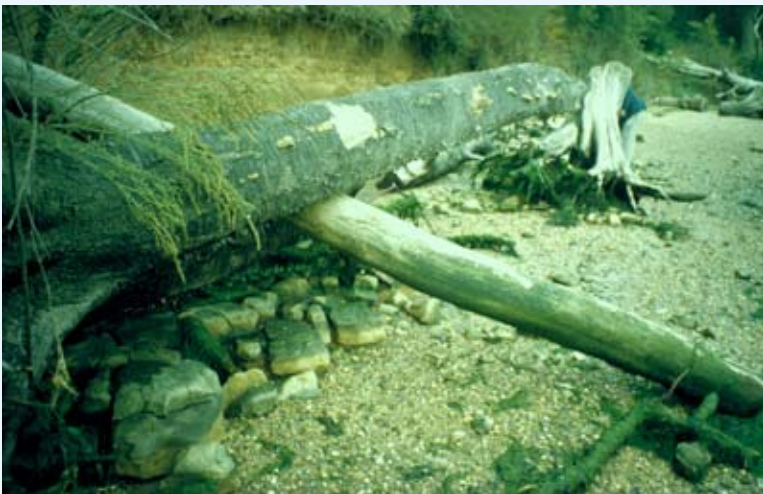
Septaria at Harwich in eastern England used for production of Roman cement. Exported to western part of Sweden during 1860th.

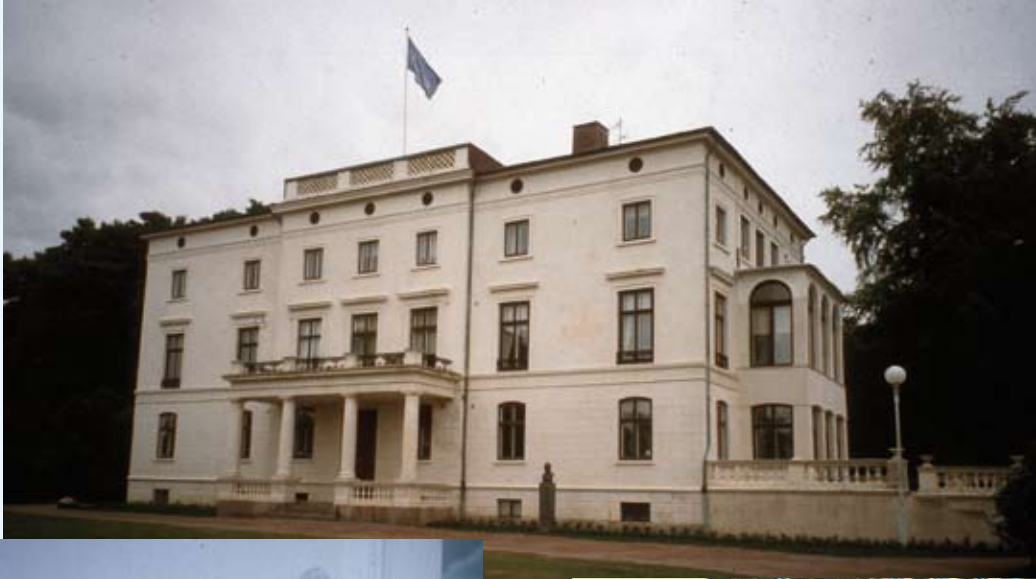
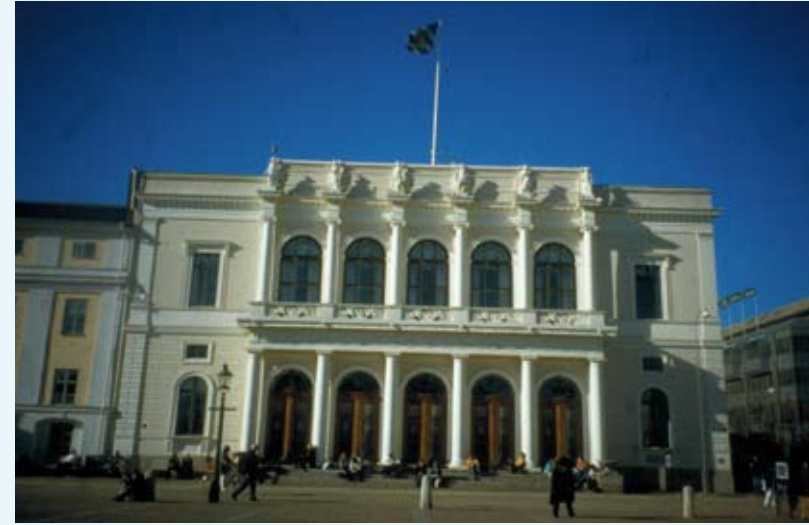
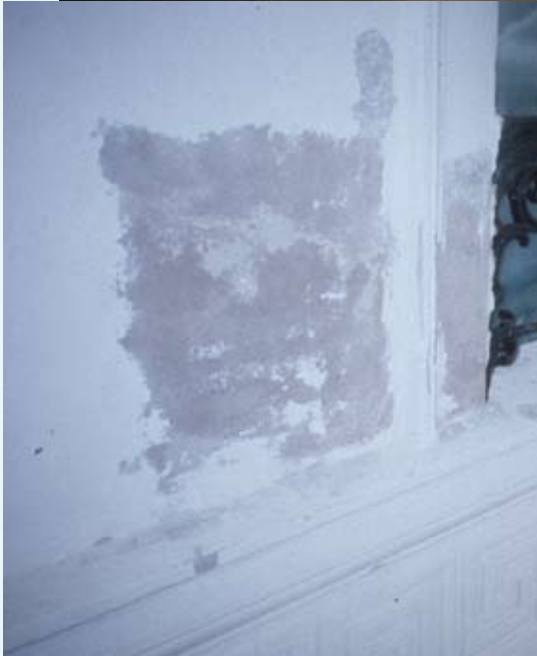
Natural cement - The first examples

Stock Exchange building Göteborg (1844-49). Architect P J Ekman. Render and certain façade ornaments. Produced in Hull. Craftsmen from Hamburg.

Essen Villa Helsingborg (1846-48). Arkitekt G F Hetsch Denmark. Render and facade ornaments. Red-brown. Produced in England or Copenhagen. CI = 0,53 (moderately hydraulic lime)?

At first lime washed (grey-brown) and later painted with linseed oil paint (white and brown shades).

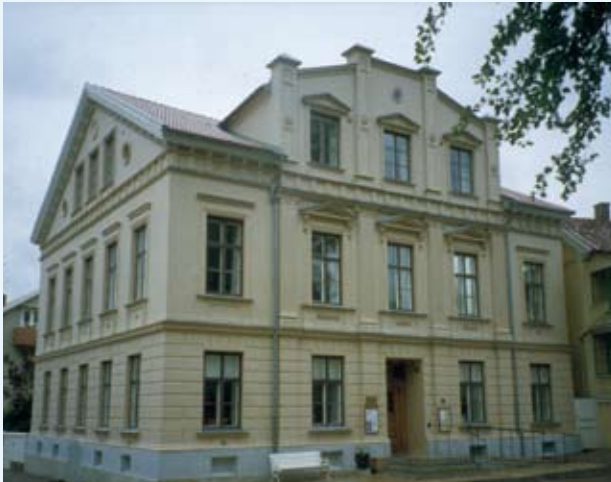
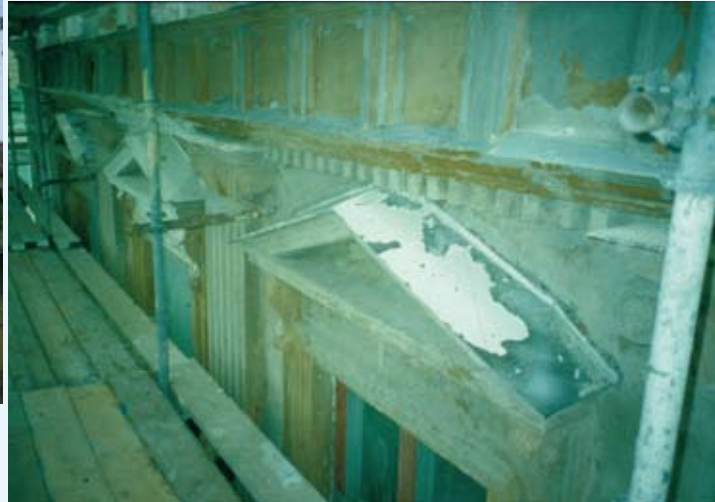
Natural cement - Town Hall

Town Hall Marstrand (1867).
Facade ornaments of natural cement. Light or dark yellow-red-brown. Render of early Portland cement. Produced in Hull by cementstone from Whitby Yorkshire? CI = 0,55 (moderately hydraulic lime)?

At first no paint. Later limewashed with pure lime and hydraulic lime (red-brown) and painted with linseed oil paint.

Restored 2000 with portland cement, cement lime mortar and painted with linseed oil paint and cement lime paint (red-brown).

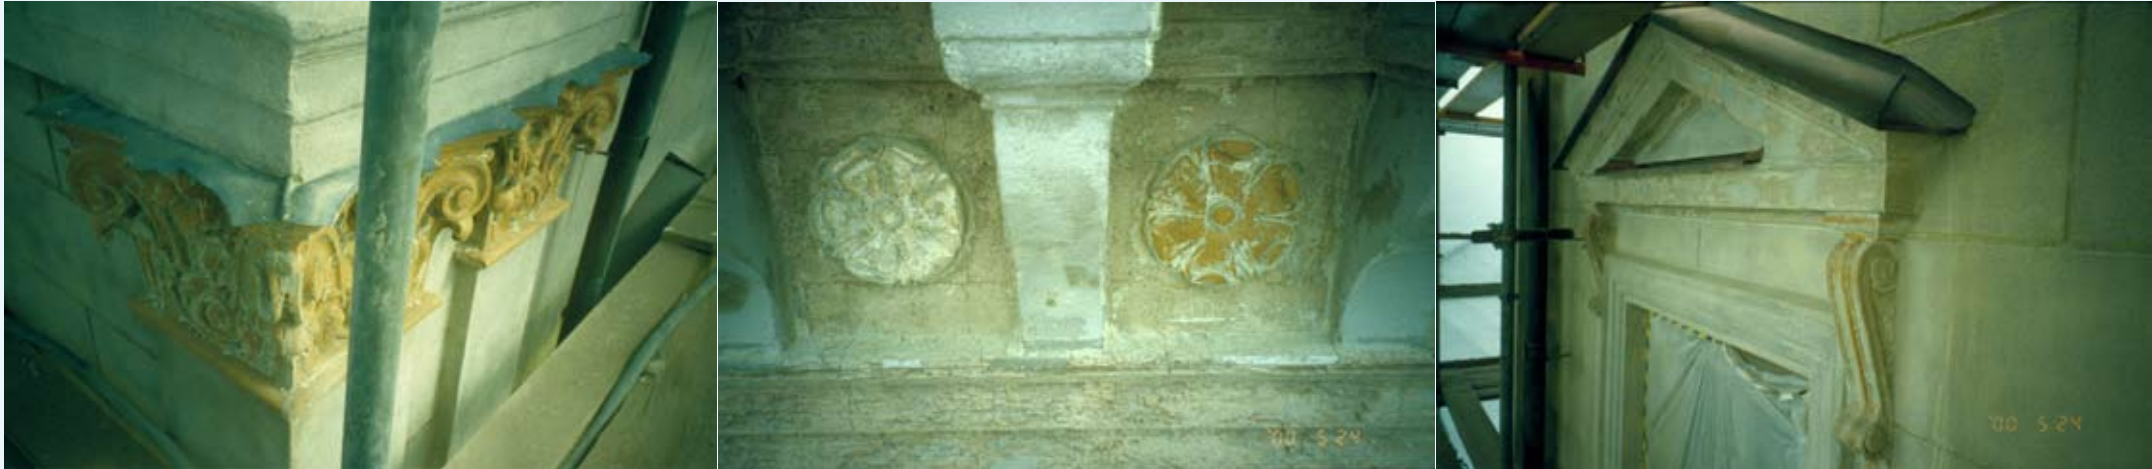
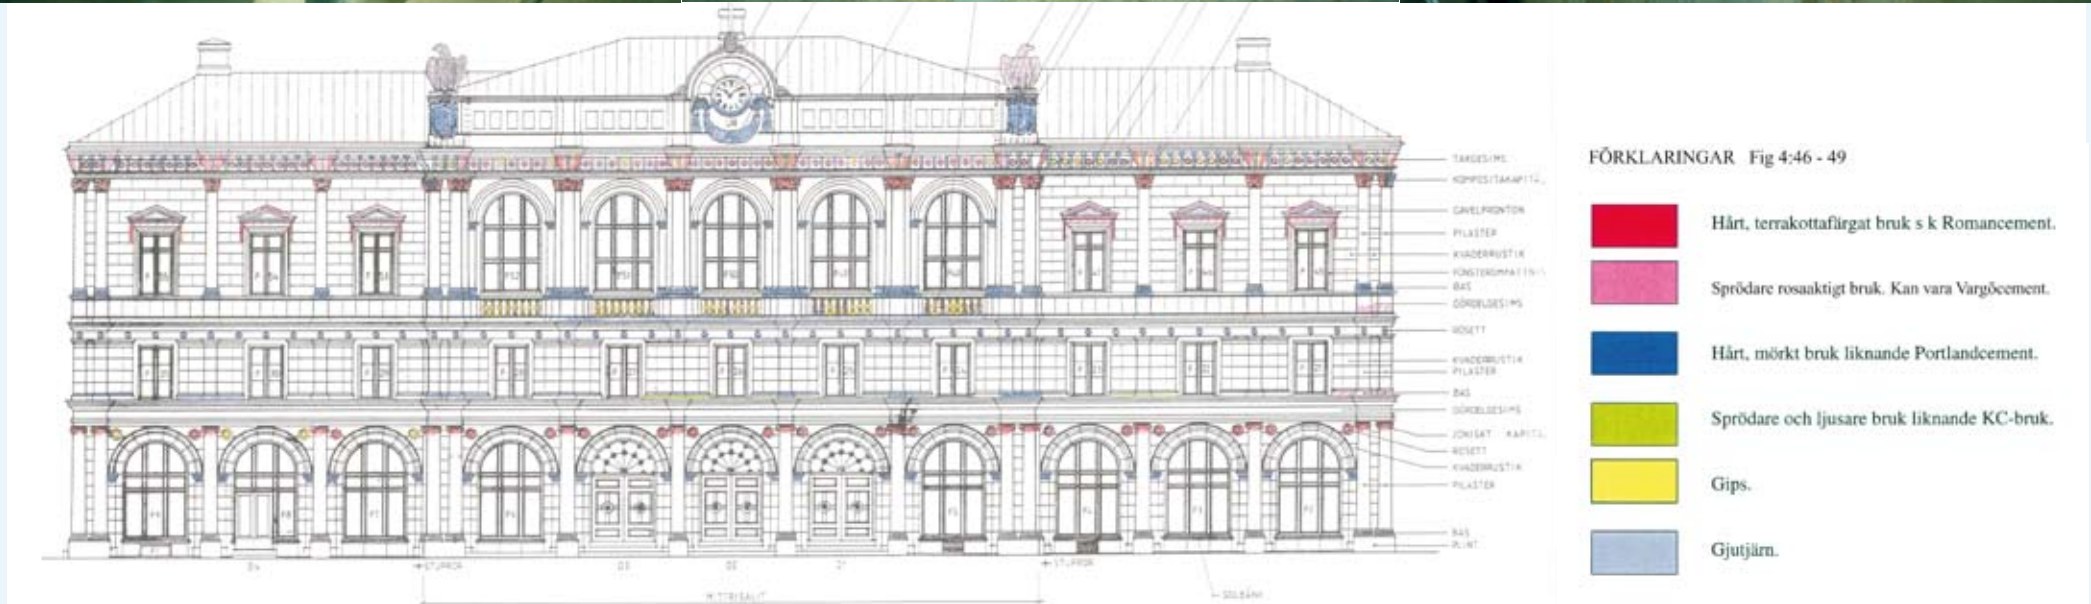
Natural cement - Town Hall Karlstad

Town Hall Karlstad (1868-69). Architect E A Jacobsson. Façade ornaments. Light yellow-brown. Original render was made of lime mortar (Kinnekulle lime?). Produced in Hull? Very alike the natural cement at Town Hall Marstrand.

At first limewashed with hydraulic lime and later painted with linseed oil paint.

Restored 2000 with portland cement and linseed oil paint.

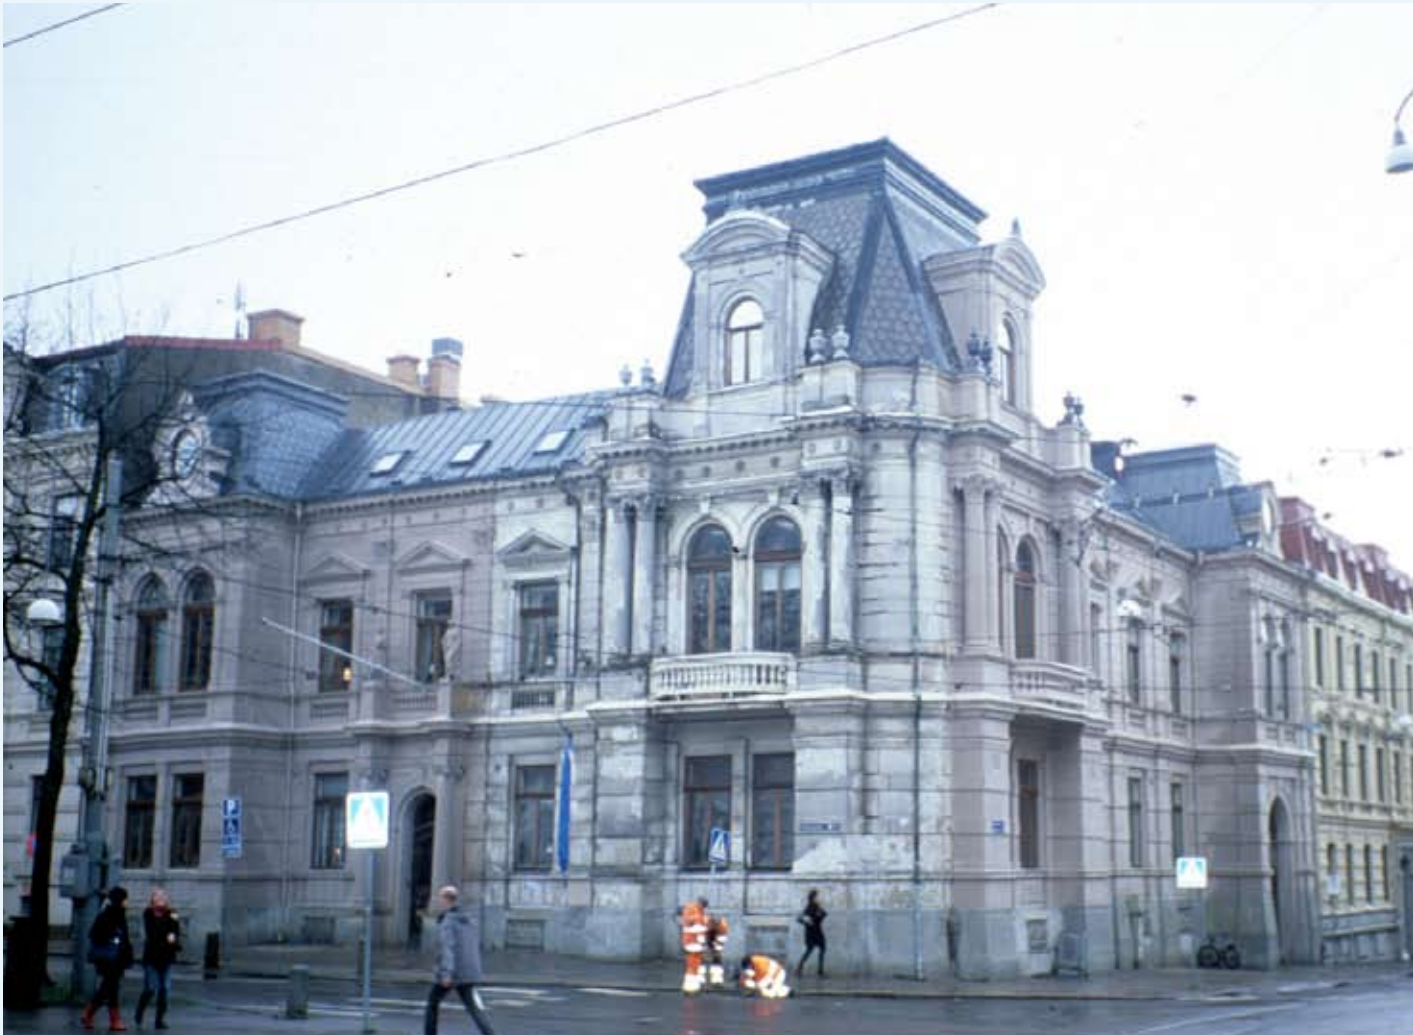
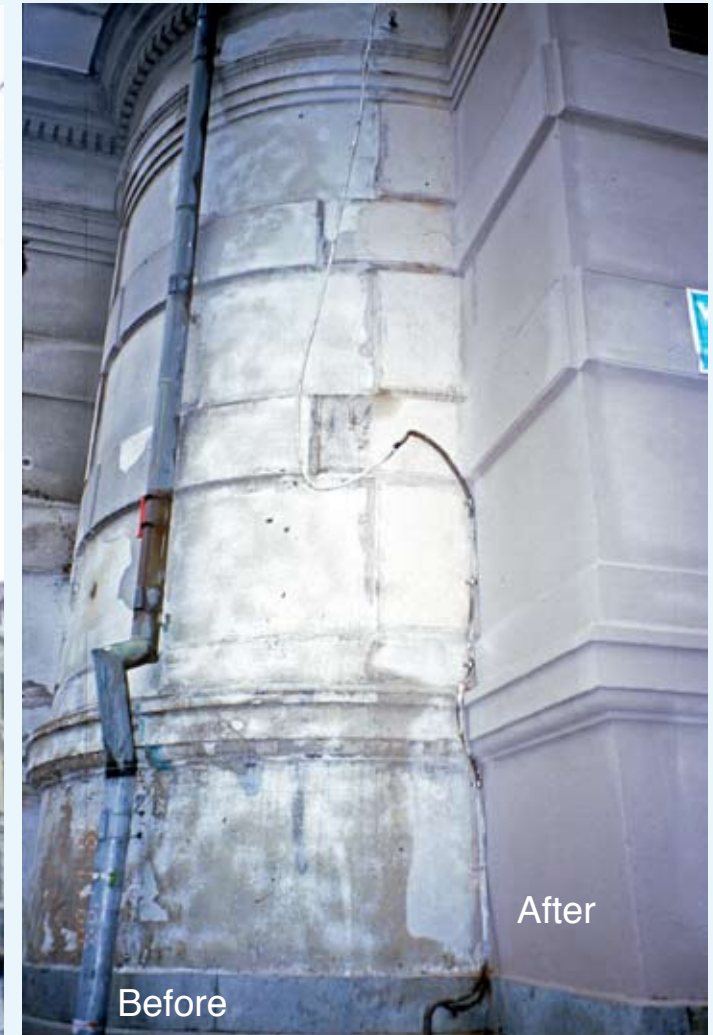
Natural cement - Heyman Villa Göteborg

Heyman Villa Göteborg (1874). Architect Adrian C Peterson. Finishing and façade ornaments of natural cement above Portland cement. Brownish.

Painted with silicate paint 1882 and 2008.

Restoration going on 2008.

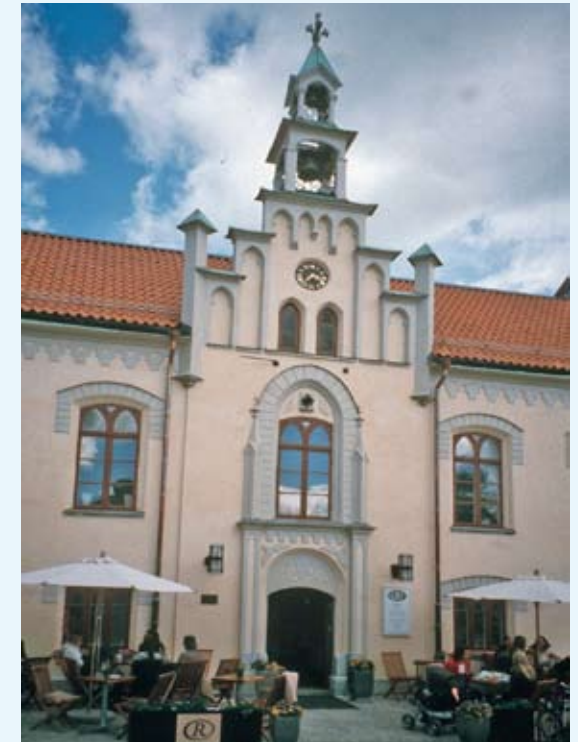
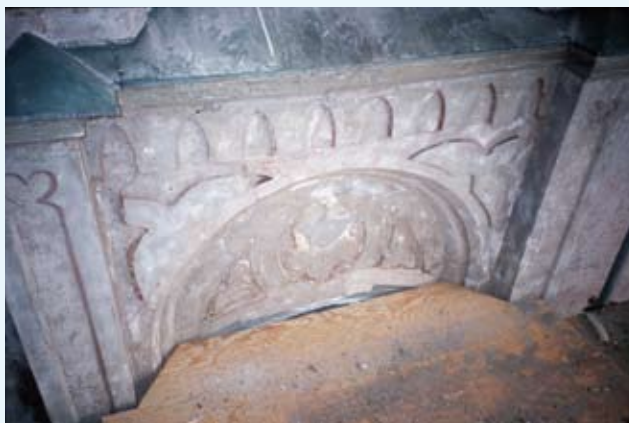
Early Portland cement - Old Town Hall Skövde

Old Town Hall Skövde (1852-53). Architect Hjalmar Wijnblad. Render. Light grey/grey. Finishing of pure cement above a lime cement mortar (LC 80/20/600).

At first painted with linseed oil paint (light yellow).

Restored 2005 with lime cement mortar and lime cement paint (light yellow).
